CRASH INJURY EVALUATION

AO-1BF MOHAWK MOCKUP

AO-1BF U. S. ARMY "MOHAWK" MOCKUP EVALUATION
Bethpage, Long Island, New York
31 March 1960

REPORT OF CRASH INJURY EVALUATION
AvCIR-12-PV-117
August 1960

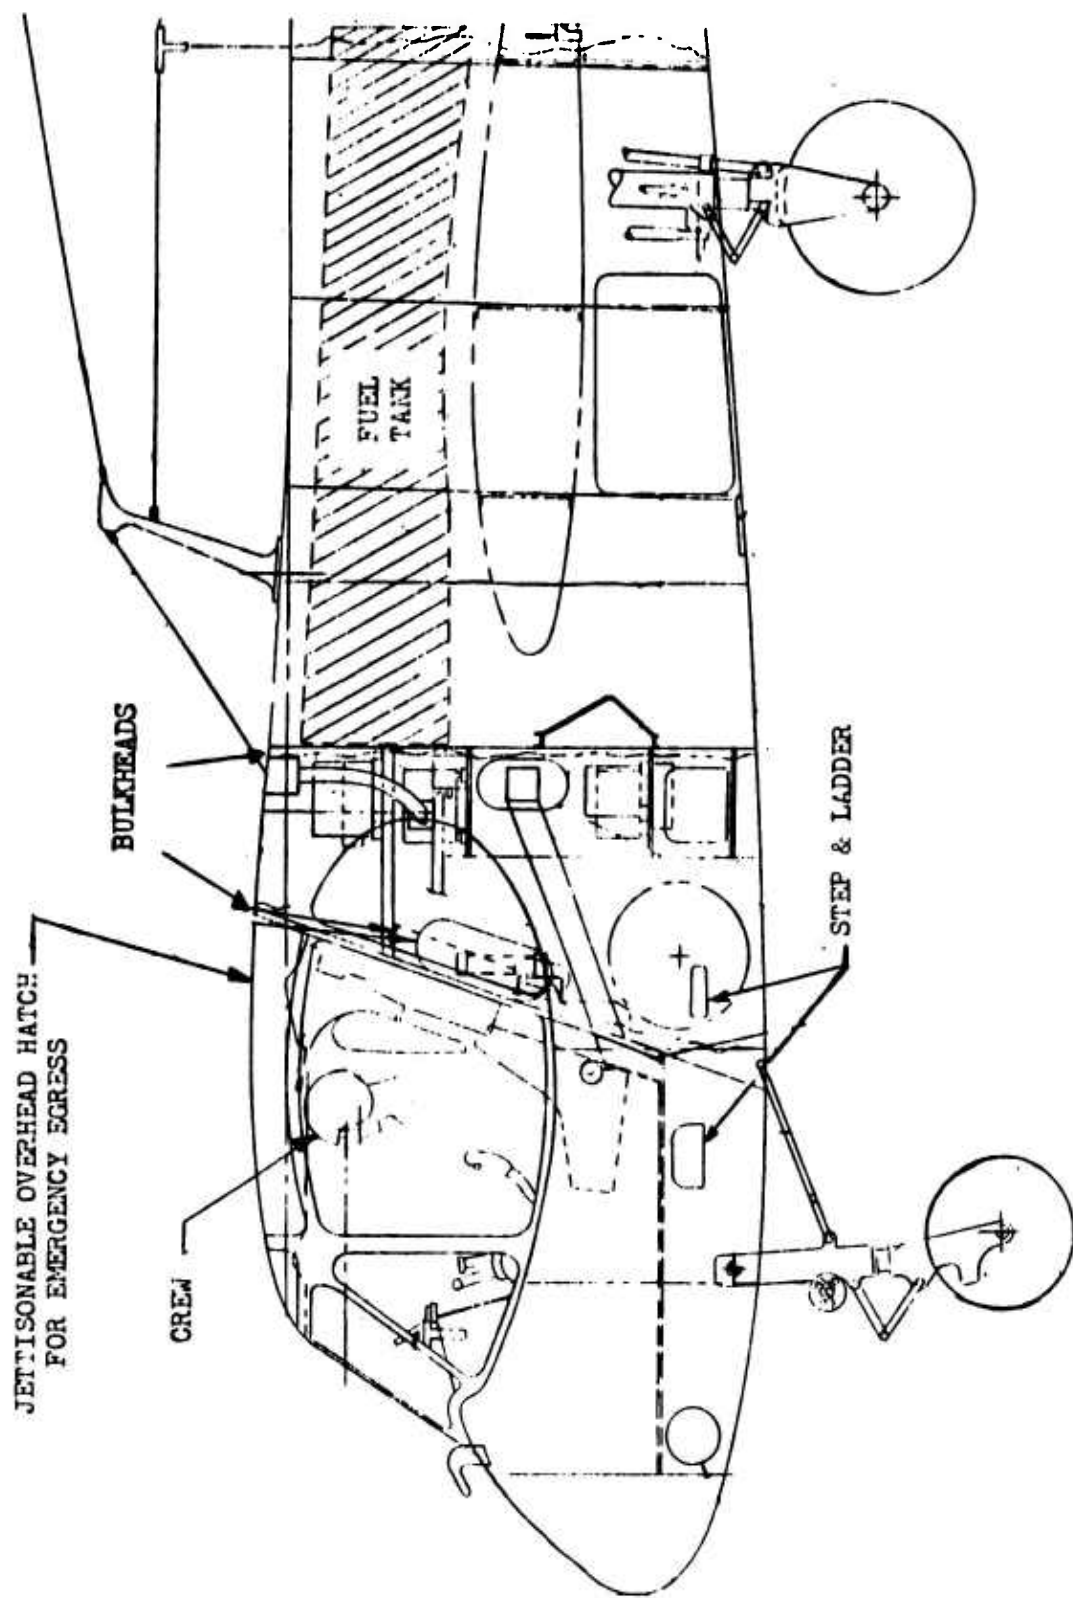
Figure 4. A reduced scale drawing of the forward portion of the Mohawk. Note the normal seated position of the pilot.

1. The cockpit is stressed for 40 G.
2. The self-sealing fuel tank, Figure 4, is located in the fuselage above the center section with two bulkheads separating the fuel tank area from the cockpit.
3. Further protection is afforded by the one-inch thick windshield and utilization of 1/2 -inch armor plate for the cockpit floor.
4. The relatively slow landing speed (55 knots) is also a desirable feature.
5. The Mohawk utilizes an in-flight fire extinguishing system in the engine nacelles, which is manually controlled by the pilot. Substantial post-crash fire protection could be provided with the incorporation of an impact actuated switch in this system. (See Post-Crash Factors in Appendix I.)

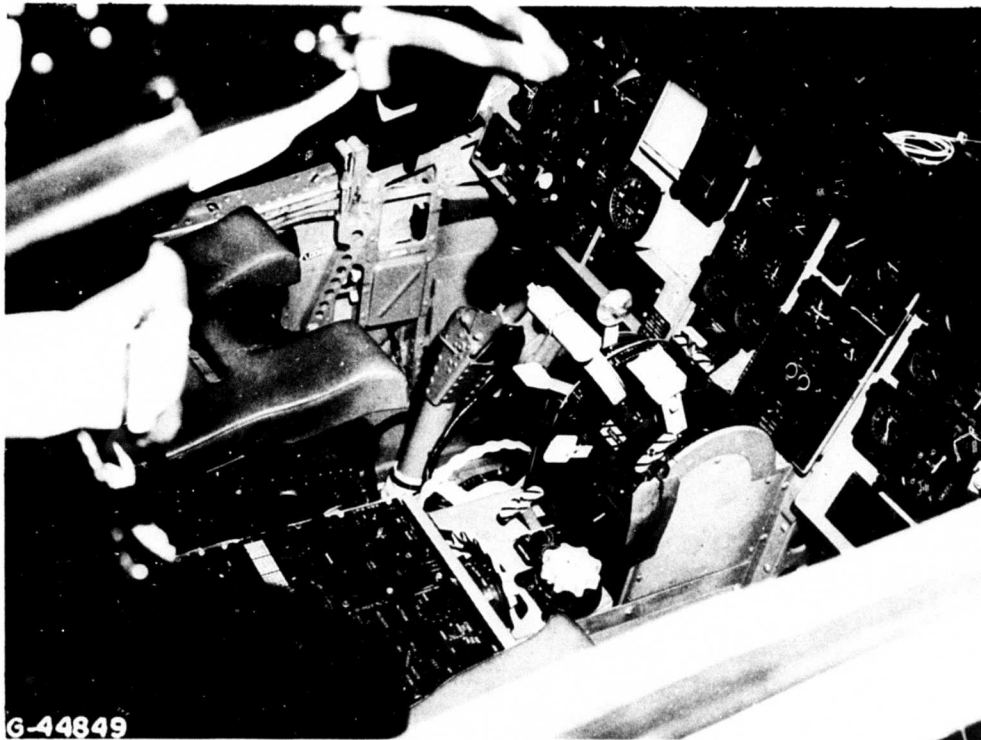
The overall cockpit view, Figure 7, shows the compactness and the full utilization of all the available space in the Mohawk.

Figure 7. Overall cockpit view.

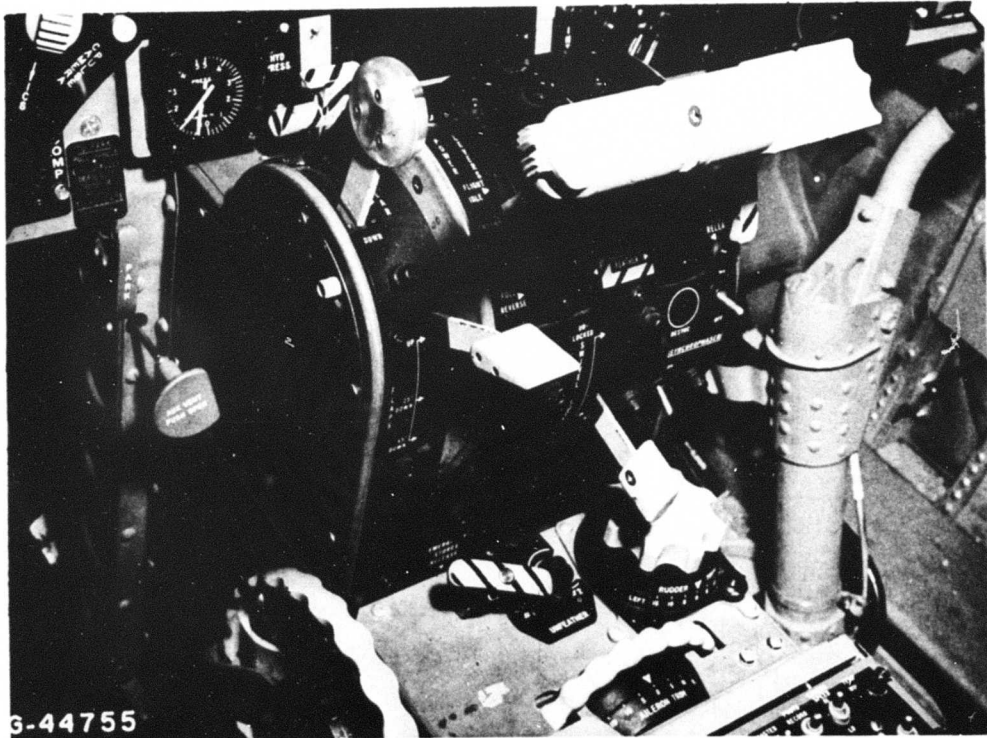
Figure 12. Close-up view of the engine control pedestal.

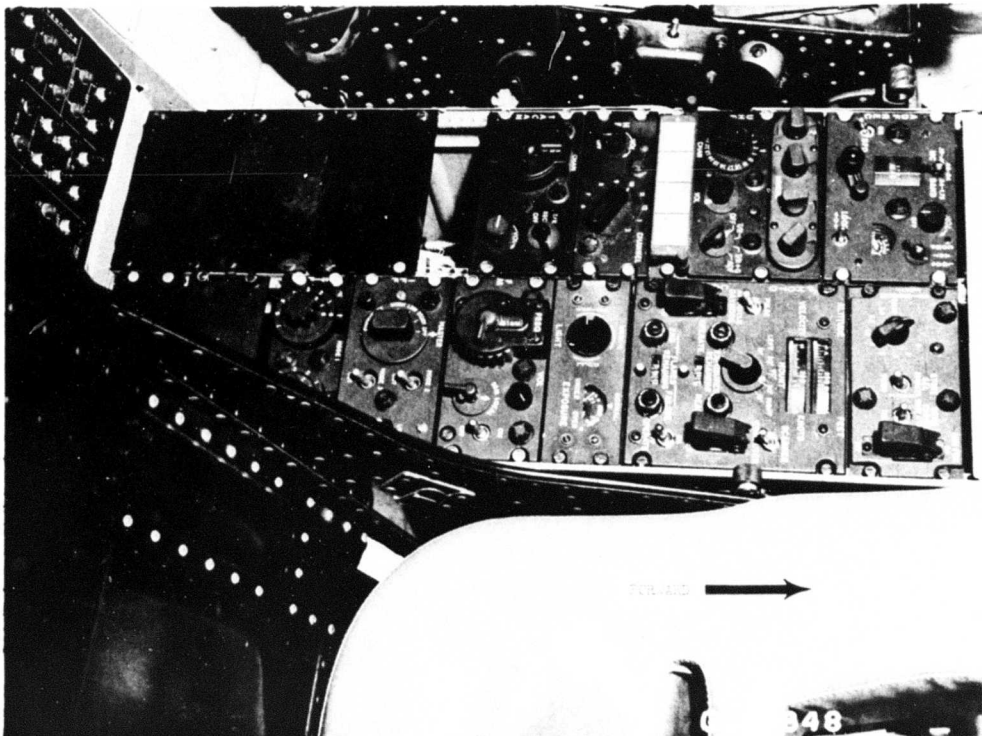
Figure 13. Radio console panel located between the occupants' seats.
